Product tech note – compressor gear set

Wilcoxon Sensing Technologies accelerometers detect low frequencies for monitoring of critical turbo-compressors

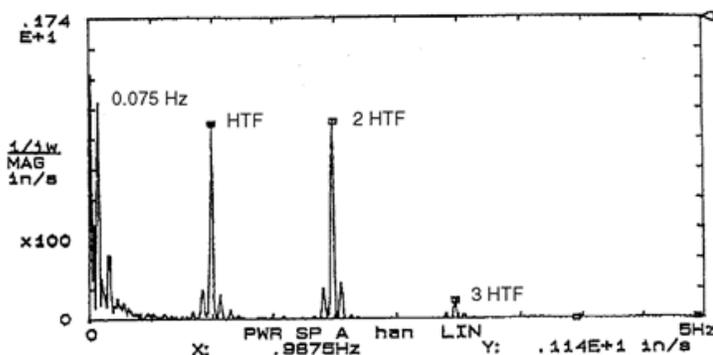
Measurements on the speed increaser indicated significant high amplitude, low frequency vibrations from the high-speed coupled end of the gear box. The spectra shown in figure 1 reveals a very low frequency pulsation at 0.075 Hz (4.5 cpm), and a 1.26 ips vibration at the hunting tooth frequency (HTF) of 0.99 Hz (59.4 cpm). Harmonics of the HTF and sidebands of the pulsation signal are also visible.

Figure 1: Surge frequency and hunting tooth harmonics from speed increaser measurement

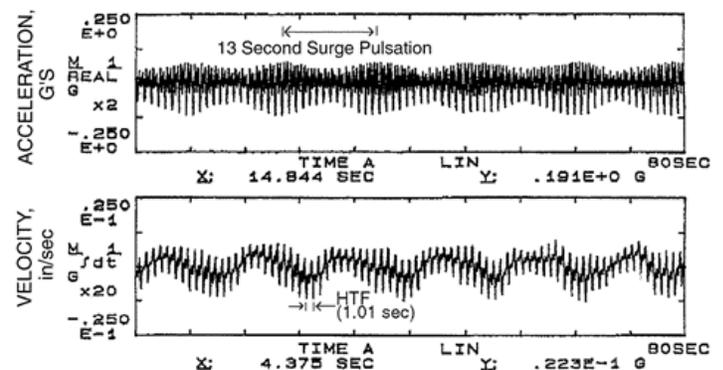
The pulsation produced a beat every 13 seconds (see figure 1b) and was believed to be process related, resulting from surge. The surge was caused by trapped pockets of air in the influent lines of the chiller. The time waveforms and sidebands around the HTF, suggested that the surge pulsation was amplitude modulating the hunting tooth harmonics.

Figure 1b: Time waveform showing modulating effects of surge pulsation

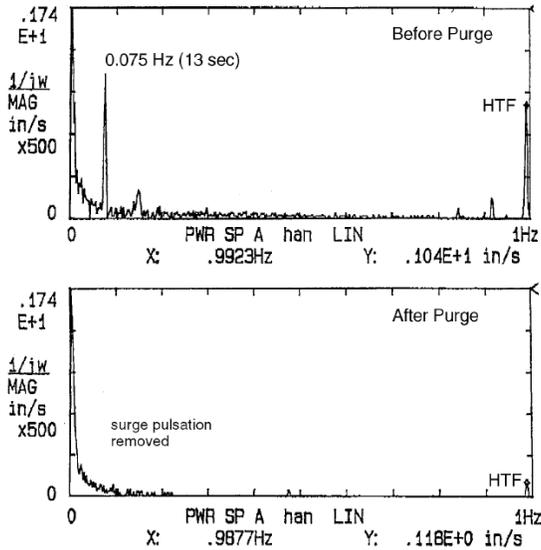
Figure 2a: Surge pulsation before and after purging of refrigerant

In order to decrease the pulsation, the refrigerant in the delivery system was purged of air. Follow up measurements indicated that purging had completely removed the low frequency surge (see figures 2a and 2b) and substantially reduced the modulated HTF amplitude from 1.16 ips to 0.11 ips.

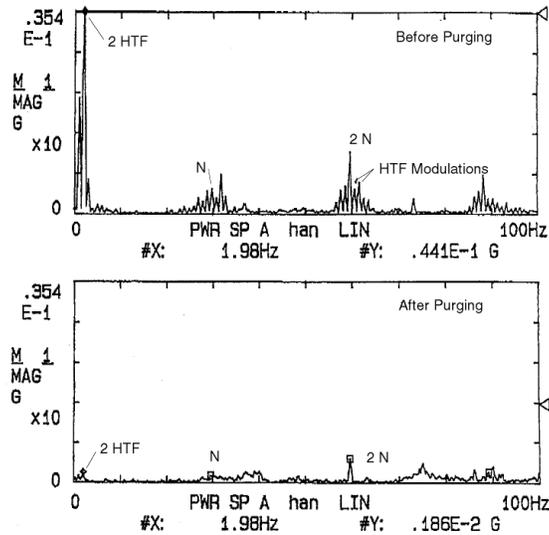
The modulating effects of the HTF upon the gear/motor running speed harmonics were also reduced as shown in figure 3.

Figure 3: HTF sidebands and gear mesh harmonics before and after repair

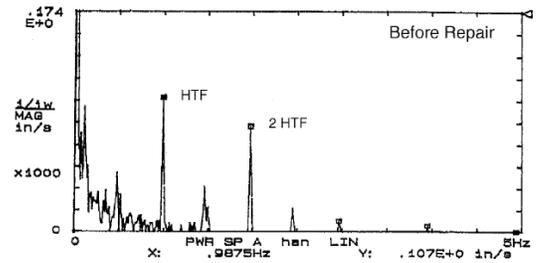
Figure 4a: Surge pulsation before and after purging of refrigerant

Baseline measurements retaken on the compressor showed the hunting tooth vibration nearly eliminated (see figures 4a through 4d). The final measurement of 0.03 ips at 0.99 Hz was determined to be an acceptable vibration level for this gear set. The compressor was placed on-line without further interruption.

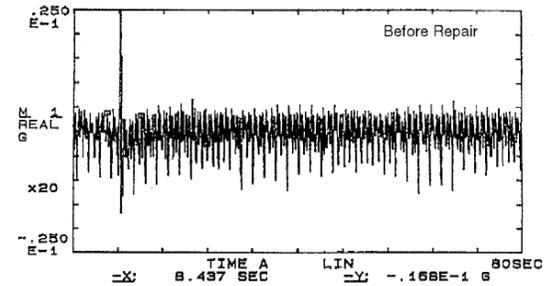
Figure 4b: Time waveform before repair

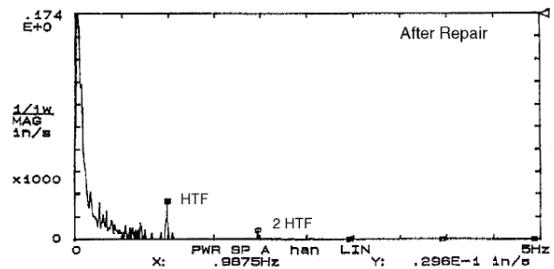
Figure 4c: Hunting tooth harmonics after gear set repair

Unfortunately, the HTF component was still prominent and indicated a potential problem with specific teeth on the gear set. Hunting tooth faults can be very difficult to physically isolate and evaluate in terms of reliability. A gear transmission consultant was therefore hired to inspect the gear set. Detailed examination revealed that an indentation had been made on corresponding pinion and gear teeth to mark the phase of assembly when the gear set was rebuilt. The gears were repaired with a fine tooth file and re-installed for start-up.
