Product tech note – compressor gear set

Wilcoxon Sensing Technologies accelerometers detect low frequencies for monitoring of critical turbo-compressors

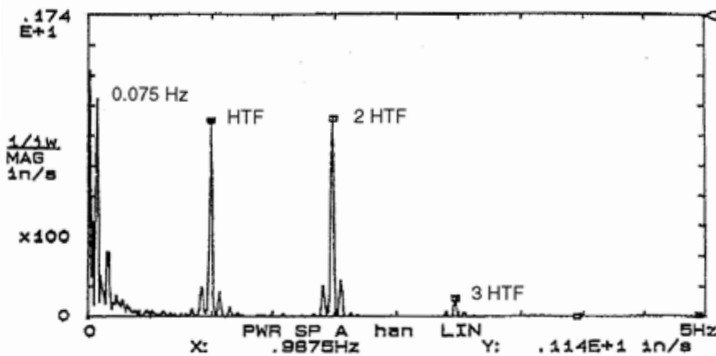
Measurements on the speed increaser indicated significant high amplitude, low frequency vibrations from the high-speed coupled end of the gear box. The spectra shown in figure 1 reveals a very low frequency pulsation at 0.075 Hz (4.5 cpm), and a 1.26 ips vibration at the hunting tooth frequency (HTF) of 0.99 Hz (59.4 cpm). Harmonics of the HTF and sidebands of the pulsation signal are also visible.

Figure 1: Surge frequency and hunting tooth harmonics from speed increaser measurement

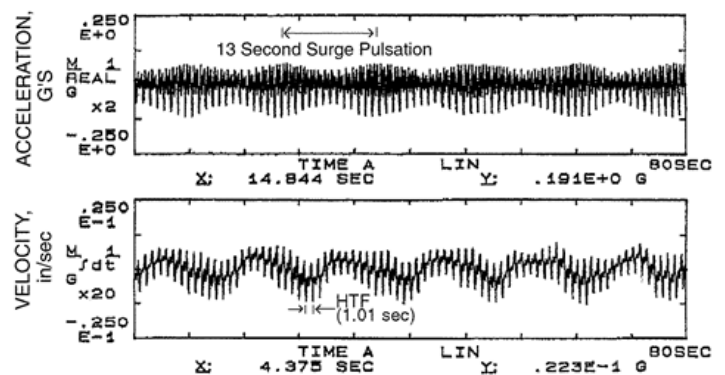
The pulsation produced a beat every 13 seconds (see figure 1b) and was believed to be process related, resulting from surge. The surge was caused by trapped pockets of air in the influent lines of the chiller. The time waveforms and sidebands around the HTF, suggested that the surge pulsation was amplitude modulating the hunting tooth harmonics.

Figure 1b: Time waveform showing modulating effects of surge pulsation

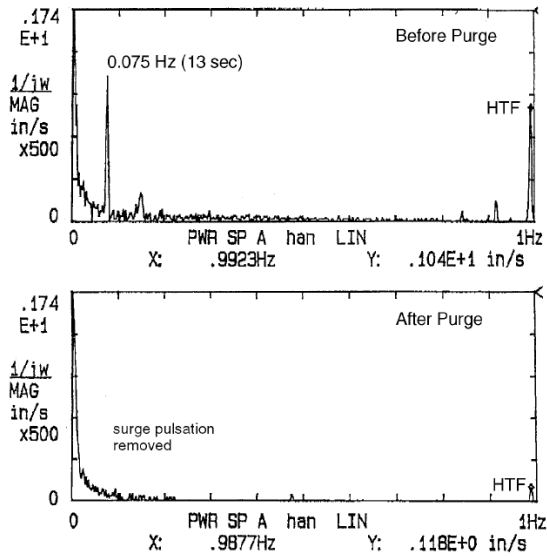
Figure 2a: Surge pulsation before and after purging of refrigerant

In order to decrease the pulsation, the refrigerant in the delivery system was purged of air. Follow up measurements indicated that purging had completely removed the low frequency surge (see figures 2a and 2b) and substantially reduced the modulated HTF amplitude from 1.16 ips to 0.11 ips.

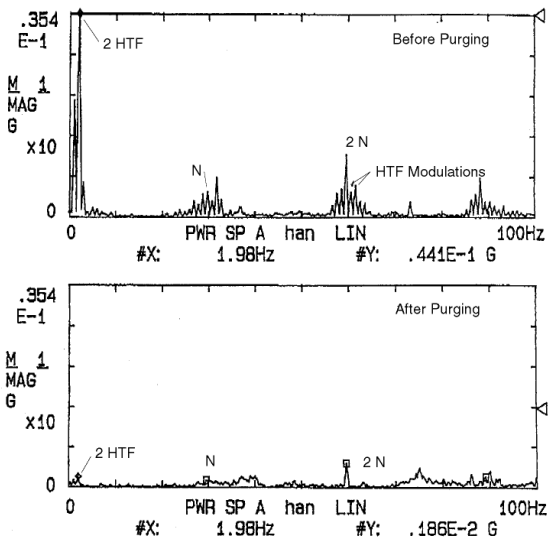
The modulating effects of the HTF upon the gear/motor running speed harmonics were also reduced as shown in figure 3.

Figure 3: HTF sidebands and gear mesh harmonics before and after repair

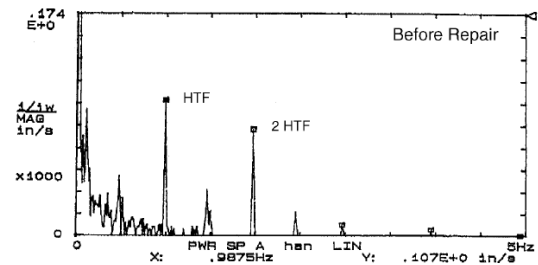
Figure 4a: Surge pulsation before and after purging of refrigerant

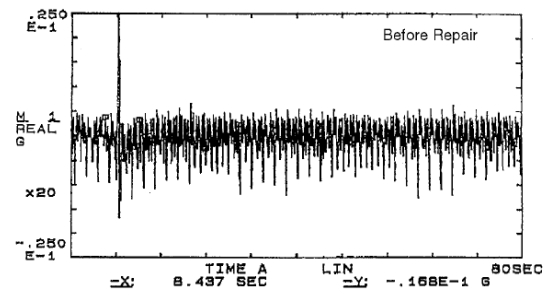
Figure 4b: Time waveform before repair

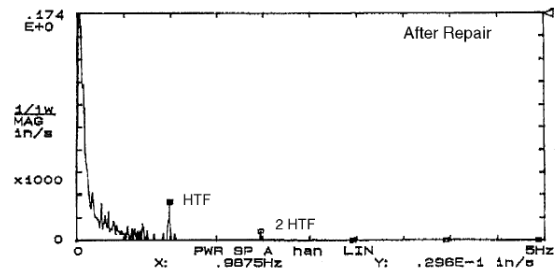
Baseline measurements retaken on the compressor showed the hunting tooth vibration nearly eliminated (see figures 4a through 4d). The final measurement of 0.03 ips at 0.99 Hz was determined to be an acceptable vibration level for this gear set. The compressor was placed on-line without further interruption.

Figure 4c: Hunting tooth harmonics after gear set repair

Unfortunately, the HTF component was still prominent and indicated a potential problem with specific teeth on the gear set. Hunting tooth faults can be very difficult to physically isolate and evaluate in terms of reliability. A gear transmission consultant was therefore hired to inspect the gear set. Detailed examination revealed that an indentation had been made on corresponding pinion and gear teeth to mark the phase of assembly when the gear set was rebuilt. The gears were repaired with a fine tooth file and re-installed for start-up.
