Cooling Tower Application Study

By Peter Eitnier, Senior Application Engineer, Wilcoxon Sensing Technologies
with input from Ron Peterson, Reliability Specialist, Aux Sable

Part I – Motor Madness

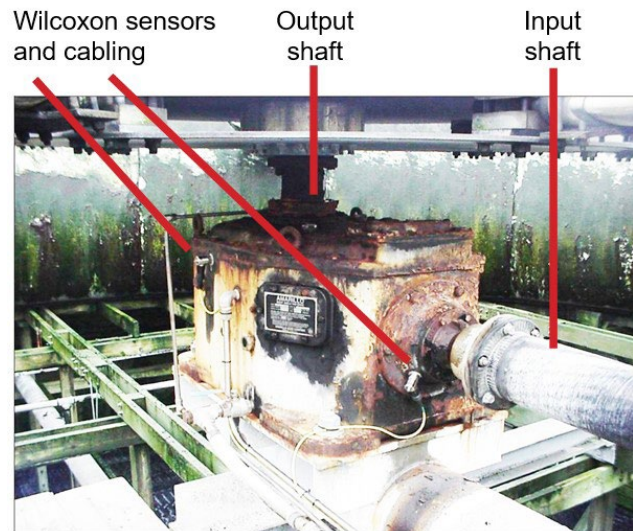
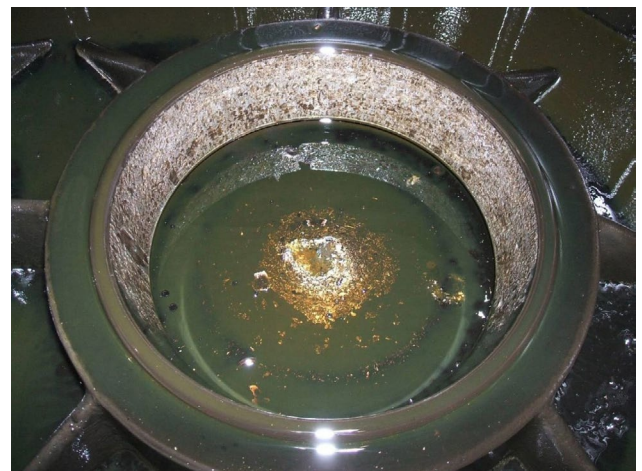
Vibration data was collected monthly from the enclosures and analyzed by the technicians. In October of 2008, the vibration trend showed a large increase and tripped a pre-programmed alert level. In addition to oil analysis from months earlier, which indicated abnormal wear on the gearbox bearings, the vibration analysis showed a bearing defect on the gearbox bottom output shaft bearing. The gearbox was replaced during a planned outage, and an inspection of the bearing confirmed what the sensors had been measuring. The image to the right shows extensive metal fatigue. Nearly 60% of the outer raceway had been eroded. All 21 of the tapered rollers on the bottom output shaft bearing and the output shaft inner race exhibited heavy corrosion damage.

Because vibration monitoring triggered a warning before the gearbox reached catastrophic failure, only the bearings and seals had to be replaced. All other major gearbox components, including the gear sets, were in good condition. The repair costs totaled just under \$2,700, while a rebuild would have cost over \$13,000 more. Furthermore, if the gearbox had run to failure and had not been replaced during a planned outage, the fan's unplanned downtime and reduction of cooling water may have caused a loss of productivity during peak demand.

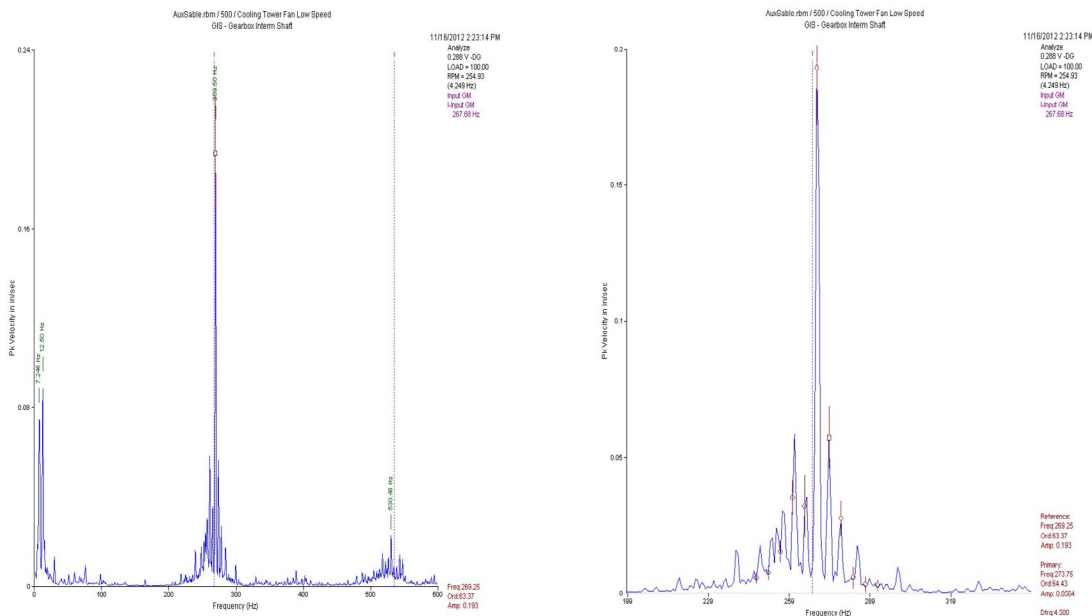
Vibration analysis indicated a spike in amplitude at the gear mesh frequency of 269 Hz. The graphs below represent the spectral data from the vibration sensors over the full frequency range (left) and the expanded troublesome spectrum (right). The expanded spectrum shows numerous sideband frequencies at intervals of 4.5 Hz, associated with the gearbox intermediate shaft speed. The amplitude was approximately 30% of the fundamental frequency, a moderate severity level.

A waterfall plot tracked over the year showed a continuous increase in the amplitudes of both the gear mesh frequency and sidebands. The gearbox was replaced with a spare at the first opportunity and repairs were made.

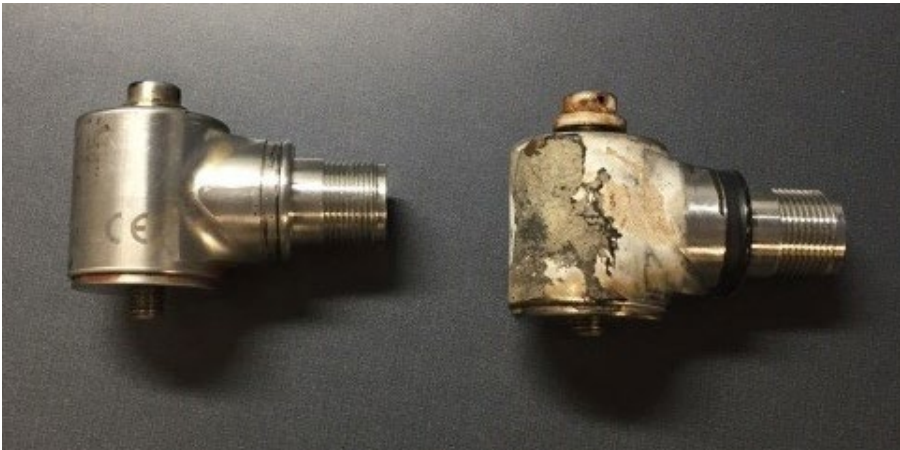
After more than 10 years of operation in the cooling tower and being subjected to sulfuric acid, water spray, dirt and grime, the sensors were uninstalled and replaced. The image directly below shows the two sensors that came off the gearbox in 2012. The left sensor has been rubbed clean of most contaminants, while the sensor on the right appears as it did when it was removed from operation. Despite the harsh, wet and corrosive environment, both sensors still performed as they did at commissioning.
