Benefits of IEPE accelerometer isolation design

By Renard Klubnik

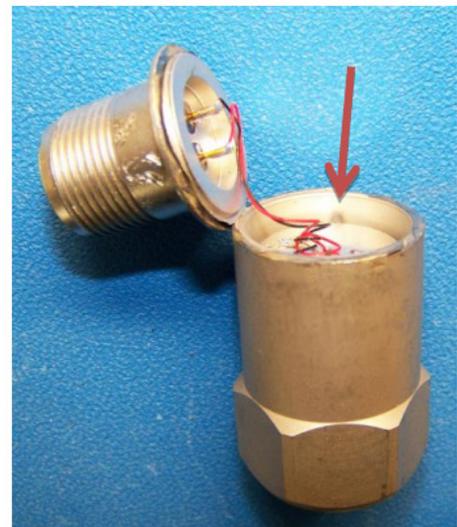
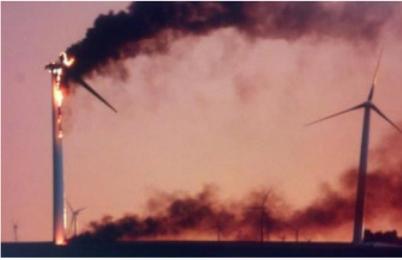
The photo to the right is an accelerometer from a wind tower that sustained a lightning strike. Notice the small black mark indicative of the location where the energy jumped from the case of the accelerometer into the active IEPE circuit. Permanent damage to the IEPE circuit can be seen.
