Cooling Tower Application Study

By Peter Eitnier, Field Application Engineer, Wilcoxon Sensing Technologies
with input from Ron Peterson, Reliability Specialist, Aux Sable

Part I – Motor Madness

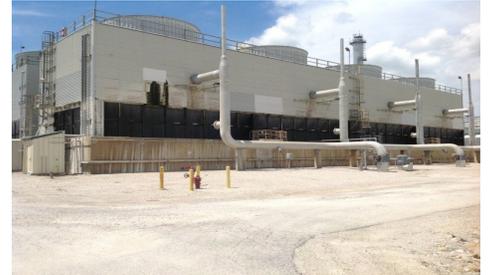
Cooling towers are a critical component in many process facilities and are made up of several different pieces of machinery that contribute to their operation. Motors, gearboxes, fans and shafts require vibration monitoring to provide technicians with early warning signs regarding impending failures that could lead to catastrophic breakdowns. Such failures can result in lowered production, safety hazards and expensive repairs that can set a site back for months.

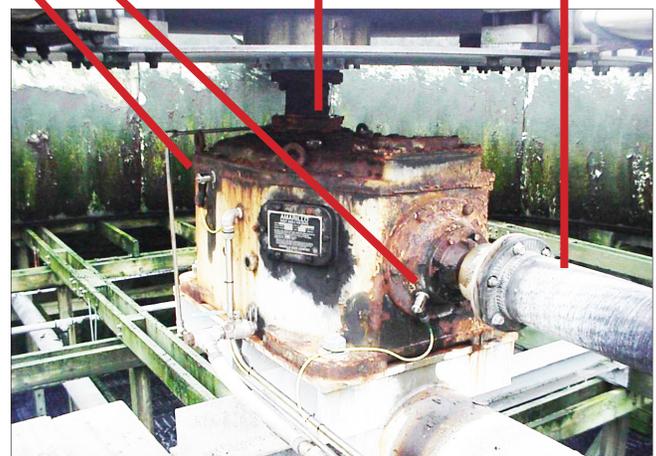
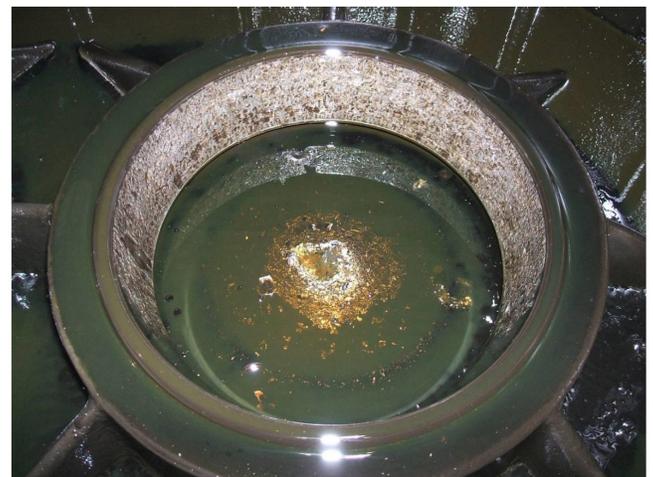
Wilcoxon sensors and cabling Output shaft Input shaft

Vibration data was then collected monthly from the enclosure and analyzed by the technicians. In October of 2008, the vibration trend showed a large increase and tripped a pre-programmed alert level. In addition to oil analysis from months earlier which indicated abnormal wear on the gearbox bearings, the vibration analysis showed a bearing defect on the gearbox bottom output shaft bearing. Upon replacement of the gearbox during a planned outage, inspection of the bearing confirmed what the sensors had been measuring. The image seen to the right shows just how bad the metal fatigue was, where nearly 60% of the outer raceway had been removed.

Furthermore, all 21 of the tapered rollers on the bottom output shaft bearing as well as the output shaft inner race exhibited heavy corrosion damage. Clearly, the vibration sensors and subsequent analysis had proved useful.

Somehow, only the gearbox bearings and seals needed replacing as all other major gearbox components, including the gear sets, were found to be in good condition. The repair costs totaled just under \$2,700 while a rebuild would have cost over \$13,000 more. This is without taking into account any losses in operations due to a reduction of cooling water had the fan not been in operation during peak demand.

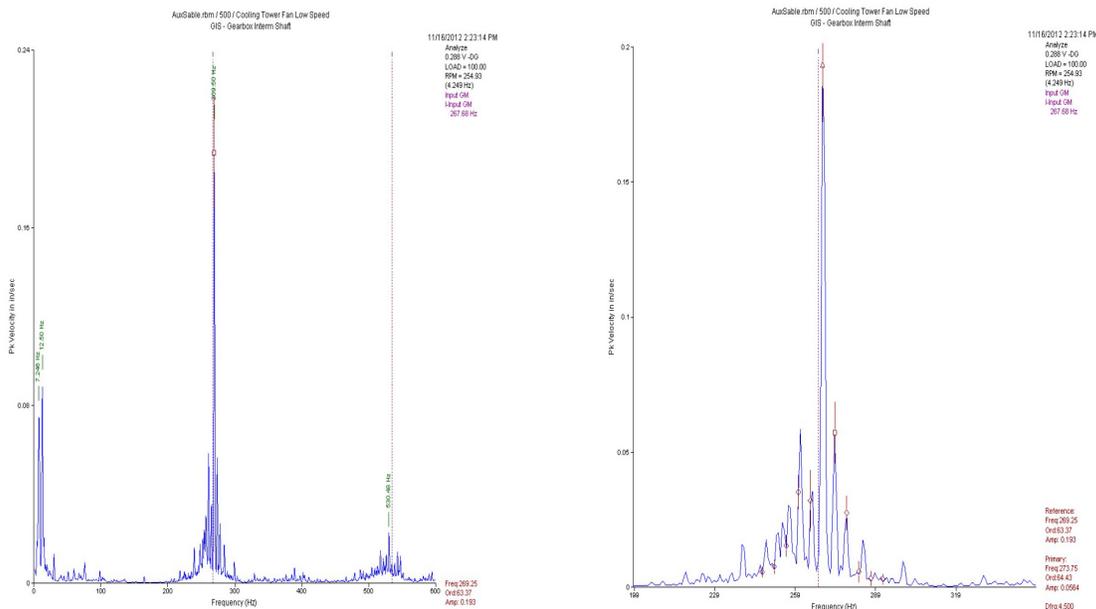
Through analysis, it was determined that there was a spike in amplitude at the gear mesh frequency of 269 Hz. Shown below (left photo) is the troublesome spectrum. The expanded spectrum (right photo) detailed the issue further as numerous sideband frequencies at intervals of 4.5 Hz appeared. These correlated with gearbox intermediate shaft speed. That the amplitude was at approximately 30% the level relative to the fundamental frequency indicated a moderate level of severity.

Finally, a waterfall plot tracked throughout the year showed the continuous increase in amplitude of both the gear-mesh frequency and sidebands. The gearbox was replaced at the first opportunity and replaced with a spare while repairs were made.

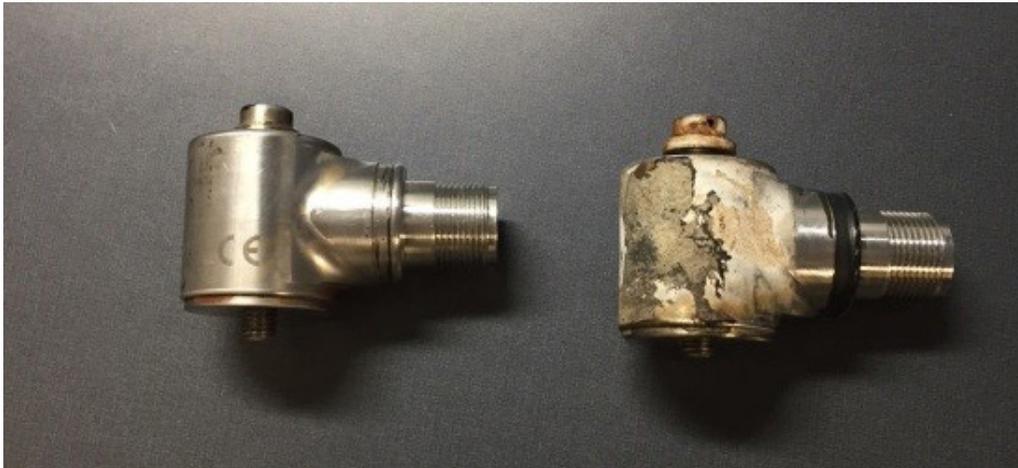
The image directly below shows the two sensors that came off the gearbox. The left sensor has been rubbed clean of most contaminants, while the sensor on the right appears just as it did when it was removed from operation. Both sensors still work exactly as they did when first commissioned, regardless of the chemicals they were subjected to, proof of the outstanding quality and durability put forward by Wilcoxon.

Paired with the R6Q(I) boot-style connector and Teflon-jacketed J9T2A cable, as seen in the image to the right, no contaminants made their way into the electrical wiring and the signal remained clear for the entirety of the sensor's lifetime.
