Product tech note – compressor gear set

Wilcoxon Sensing Technologies accelerometers detect low frequencies for monitoring of critical turbo-compressors

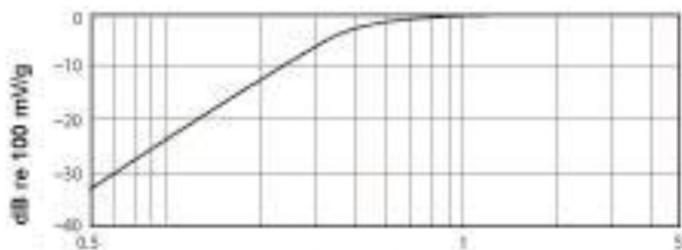
Figure 5a: Low frequency response of Wilcoxon model 766

All piezoelectric accelerometers contain a high pass filter in the amplifier to remove near DC signals. Unless low noise electronics are employed, spectral data below the specified sensor bandwidth will be overcome by 1/f noise. Figures 5a and 5b show the low frequency attenuation of the Wilcoxon model 766 output due to filtering, and the low noise floor. The output of the sensor, relative to the 100 Hz calibrated sensitivity, is attenuated by 1 dB (9%) at the hunting tooth frequency, and 26dB (95%) at the surge frequency. Even at 0.075 Hz unadjusted surge amplitude had a signal-to-noise ratio of greater than 10:1.
