Product tech note – compressor gear set

Wilcoxon Sensing Technologies accelerometers detect low frequencies for monitoring of critical turbo-compressors

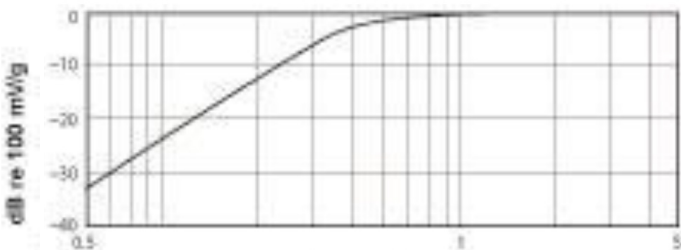
Figure 5a: Low frequency response of Wilcoxon model 766

All piezoelectric accelerometers contain a high pass filter in the amplifier to remove near DC signals. Unless low noise electronics are employed, spectral data below the specified sensor bandwidth will be overcome by 1/f noise. Figures 5a and 5b show the low frequency attenuation of the Wilcoxon model 766 output due to filtering, and the low noise floor. The output of the sensor, relative to the 100 Hz calibrated sensitivity, is attenuated by 1 dB (9%) at the hunting tooth frequency, and 26dB (95%) at the surge frequency. Even at 0.075 Hz unadjusted surge amplitude had a signal-to-noise ratio of greater than 10:1.

Table 2 shows the amplitudes of the pulsation, HTF harmonics, and sidebands, before and after filter adjustment. In cases where unexpected spectral data is measured below the specified bandwidth of the sensor, the filter attenuation may be obtained from the sensor manufacturer. This enables amplitude data (where required) to be adjusted to the correct value.
